# ALASKA VEHICLE TEST \ FINAL REPORT

## This report has been prepared for the ZERO SOUTH team and includes information required by the State of Alaska, Department of Natural Resources, in response to LAS-30762 Stipulation 25, submission of a completion report

| **Expedition** | **Alaska Vehicle Test Expedition** |

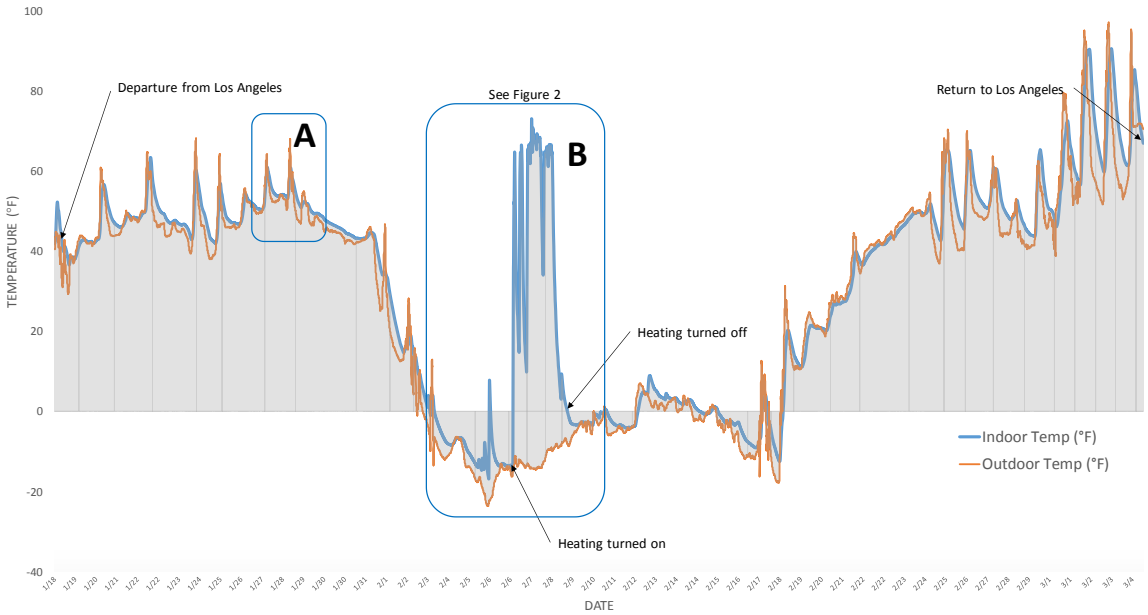
Figure 1: Outdoor & Indoor Temperature

Habitat (ZNMH) is equally critical in environmentally sensitive environments. In tow, our re-engineered Airstream (Snowstream) is equipped with aerogel thermally enhanced walls and environment appropriate heating system that uses bio-kerosene fuel to achieve a sustainable low carbon footprint. The Alaska test included a research objective to characterize the energy performance of the Snowstream and evaluate occupant thermal comfort as a function of the energy required to sustain habitat. Two Onset HOBO (U12-011) data loggers were deployed on the Snowstream with one placed inside and one outside in a weather protected enclosure. Units were placed by Eric Carbonnier of HMC Architects under the supervision of Expedition Field Science Coordinator, Jonathan Knowles. Questions we attempted to answer include, how will the aerogel walls perform in subzero environments? How much energy will it take to sustain human comfort? What strategies will the team adopt to achieve thermal comfort? Methods central to achieving a sustainable habitat require understanding the nature of four environments: the exterior environment, the Snowstream's envelope, the interior environment, and human behavior. The data loggers are mini weather stations that continuously monitor and record envelope vitals using a combination of sensors. At the end of the expedition, the devices were removed and returned for analysis. Both of the 2-channel data loggers worked to catalog over 30,000 data points of temperature, relative humidity, dew point, and a host of other operational variables. The loggers were programmed to start on January 18, 2016, and took readings every 5-minutes until March 5, 2016. The data file is available here. The outdoor temperature and indoor temperature are represented in Figure 1. Spikes in temperature reflect diurnal rhythms - noted with an A on Figure 1 - and can be seen throughout the expedition with exception when the indoor heating system was turned on - noted with a B on Figure 1. As the Polar Traverse Vehicles and Snowstream approached Alaska the ambient temperature gradually decreased as anticipated. Conversely, as the equipment left Alaska the ambient temperature gradually increased.

Two areas of interest were magnified to better understand the thermal performance of the Snowstream. Area A (Figure 1) reflects a typical non-operational status of the Snowstream. The indoor temperature swings are generally more moderate than outdoor temperatures. Indoor temperature during peak outdoor temperature remained 2-6°F cooler and 1-3°F warmer in the evening and early

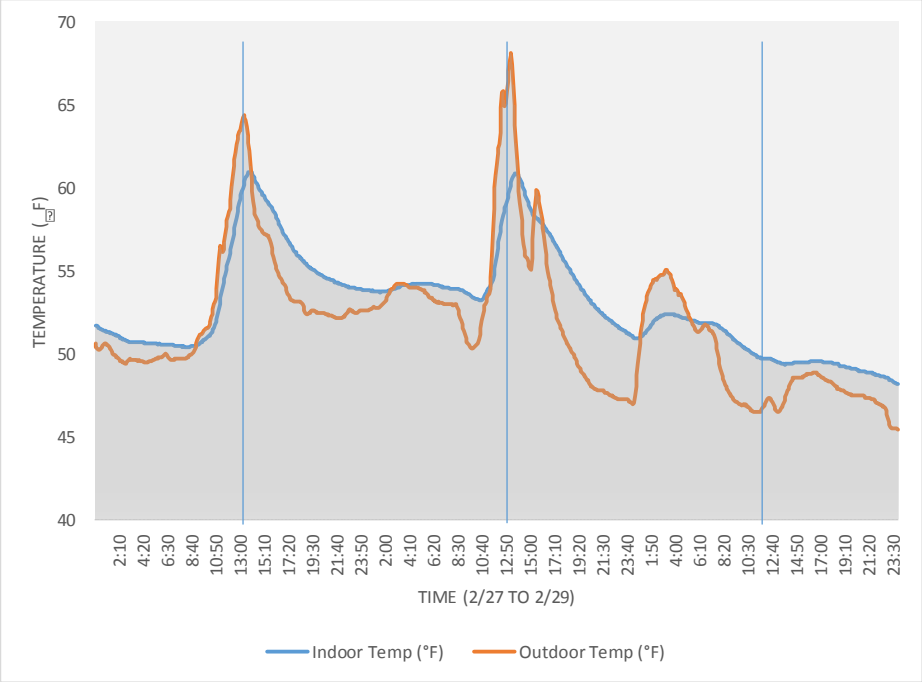
Figure 2: Area A Magnified

morning hours. These findings are to be expected and may be slightly skewed due to convective forces experienced during transport.

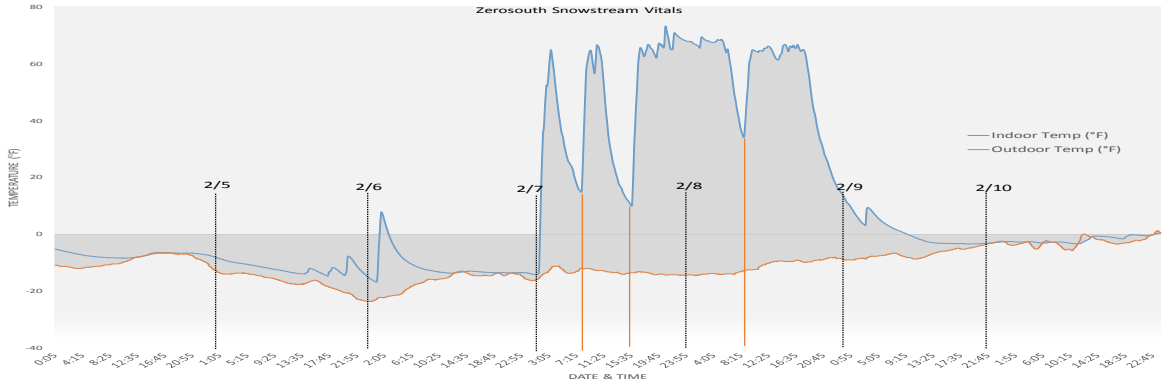
*Figure 3: Indoor & Outdoor Temperature Enlarged*

Area B in Figure 1 is magnified and illustrated in Figure 3. Area B captures February 5 through the 10 where it appears that an internal heat source was applied to the Snowstream. Based on the readings there was an anomaly around 01:25 (00:25 UTC-8) raising the temperature from -16°F to 7°F and then declining to sub-zero (°F) temperatures shortly thereafter. On February 7th it appears that a heat source was turned on at 01:45 (00:45 UTC-8) with a starting indoor temperature of -10°F and climbed to a maximum temperature of 64°F in less than 2 hours. Indoor temperatures then dropped to 14°F at 08:00 (07:00 UTC-8) when the heat source was reapplied, bringing the indoor temperature to a maximum of 66°F within 2 hours. This trend appears twice on the 7th until the evening when indoor temperatures average approximately 67°F until March 8 at 05:20 (04:20 UTC-8) when heat source was turned off or set to a lower temperature.

Based on this effort, the Antarctica expedition should deploy a more robust set of data loggers to capture broader more informative measurements including,  kBTU, C02, carbon monoxide, and track the operations of doors and vents and human behavior.
